BTA Foils 2003

C.J. Gardner

November 7, 2003

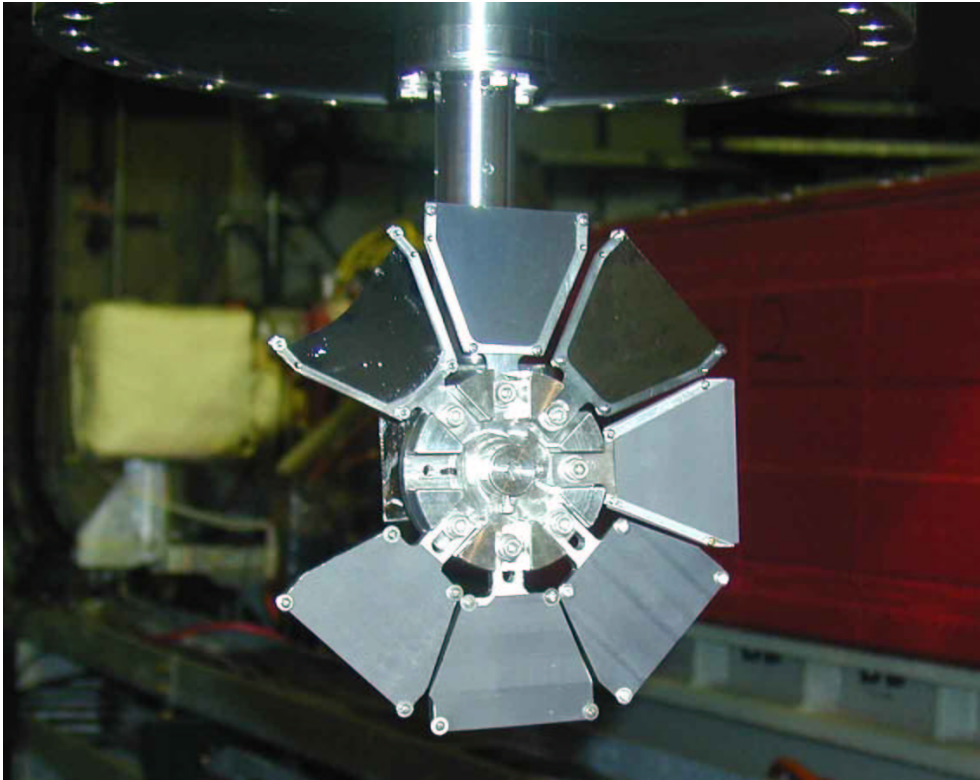
Figure 1: BTA Foils after new ones were mounted in September 2002. The beam direction here is into the picture. Holder 2 is just below the empty slot. Holders 3 through 8 follow consecutively going counter-clockwise from Holder 2.
